THE 1937-1948 CADILLAC AND LASALLE SACRIFICIAL BRONZE GEAR

THERE ARE 500 WAYS TO DO IT WRONG AND ONLY ONE WAY TO DO IT RIGHT!

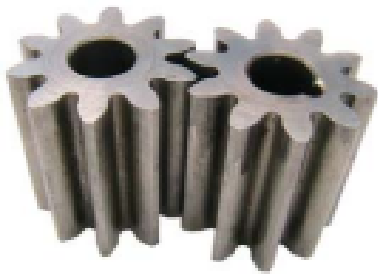
REPLACEMENT GEAR

I always put in a new oil pump when I rebuild an engine. The whole pump was available, not a kit like now. The new oil pump kits don't look like the old. The new gears are straight cut while the old ones are helical cut.

There are very few WWII era parts left so people today have new oil pump kits made. Maybe the new kits are not built to the same standards to which Cadillac made them. I sent two sets back because of binding while turning them by hand. The red flag should have come up then. At that time, I didn't know there are at least seven different oil pump casings. One size does not fit all. More about gears and pressure on the gears, helical cut or straight cut gears, is found later in this article.

At my next meeting with the Logic engineers I was much more humble. My ears were open and my mouth was shut. I learned there was going to be only one way to make this project work. The oil pump gears and housings must have the original tight tolerance, be helical cut, and must be made of a good grade of steel so as not to expand under normal operating temperatures of the engine. There could be no friction. Next to the valve train the oil pump has the most pressure on its surface. A bad oil pump gear will cause a bronze gear to fail in a short time. I'd need a bronze gear of the similar hardness as the original and a new small polished and hardened gear that would drive the oil pump and distributor. All of the small steel gears I have seen have a pattern cut in them. This was a highly polished and hardened gear when new. This is so it will not cut the bronze gear.

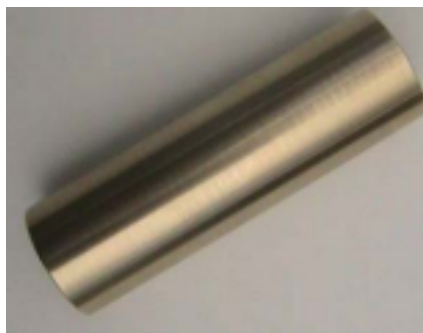
REPLACEMENT
BUSHINGS

The distributor tower needed new bushings. The bushings I checked had wear .005 to 0.025 of an inch out of round. The pressure is all one way. There are many ways to put extra pressure on the bronze gear and the gears must line up to run properly. It began to seem like the 'little retirement project' was never going to end.

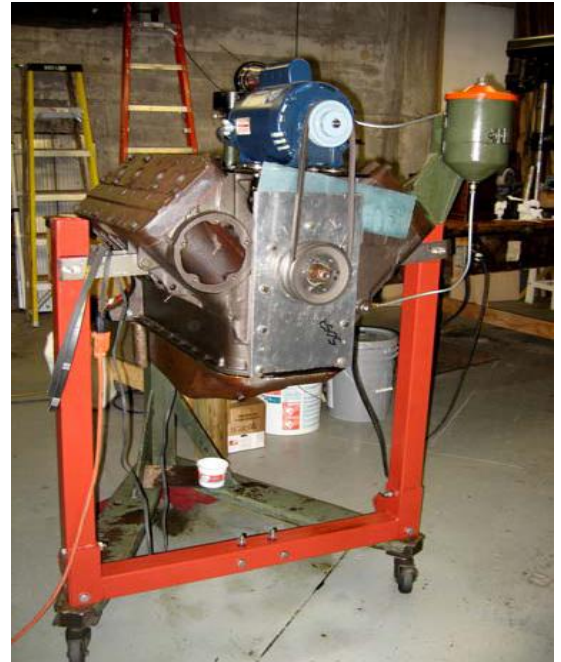
On February 16 I started the testing. I ran the engine at a speed equivalent to 70 mph with 40 lbs of oil pressure which is ten pounds more than Cadillac recommended. After the first week the engine had run the equivalent of 11,700 miles. I took everything apart and had the gears checked for wear. The bronze gear showed about 0.010 inch wear - not too good, not too bad. After the second week the equivalent travel was 23,200 miles and the gear showed 0.015 inch wear. At the end of the third week and 34,700 equivalent miles it showed about 0.025 inch wear. I had concerns at this point.

After the fourth week and 46,200 miles the gear still showed 0.025 inch wear. I felt better! After the fifth and sixth week and 57,700 miles and 69,200 miles respectively, the wear remained stable at 0.025 inch. With close to 70,000 miles completed on this test, I decided it was time to change the test to more typical operating parameters. I set the test bed to run at an equivalent speed of 55 mph with the oil pressure at 30 lbs -- the high side recommended by Cadillac.

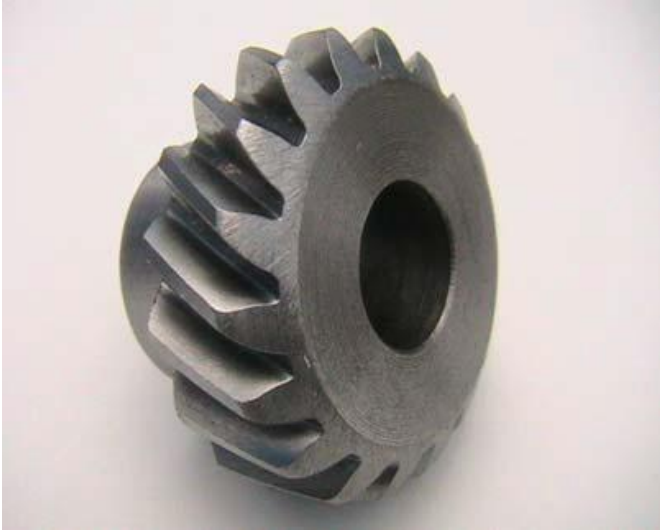
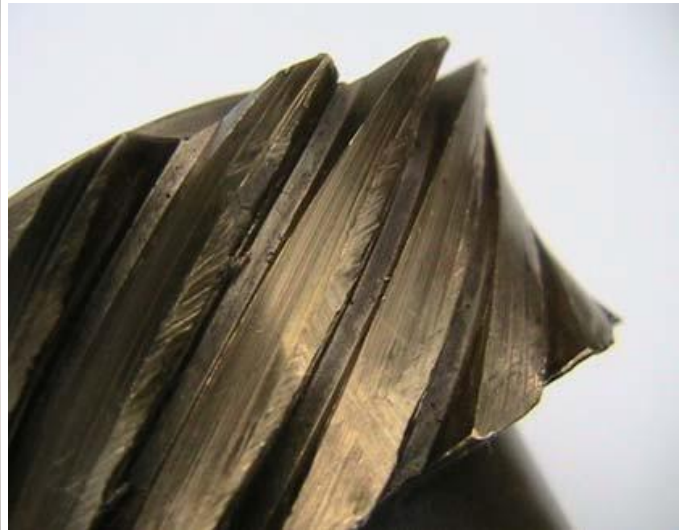
Worn steel gear. The steel drive gear was originally case hardened and polished surface. Technology of that era probably gave you a .003 to .005 thousands of hard steel. Every steel gear that I have inspected has worn thru the hardening. Viewing through a magnifying glass the teeth are very rough

Lack of a smooth surface soft steel will cause the bronze idler gear to wear at an accelerated rate.

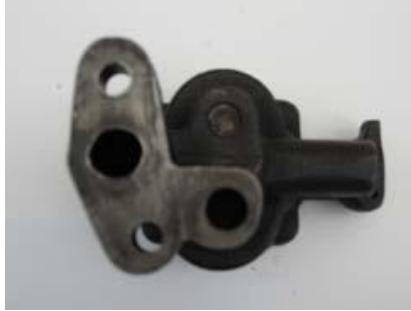
OIL PUMP CASING

Oil pump gears that bind or run at more than 30 psi oil pressure or oil pump casings that are worn at the driveshaft.

Bronze gear failure

As of now we have identified seven different casings that fit our Cadillac and LaSalle engines. All are different sizes. There can be as much as 11/1000" difference in casing sizes so we make our gears, one set at a time, to match the casing.

You can have a set of NOS helical gears but if they were not made for the casing you have, the best thing that can happen is that you lose oil pressure. The worst thing that can happen is bronze gear failure in 300 to 8000 miles.
