THE 1937-1948 CADILLAC AND LASALLE SACRIFICIAL BRONZE GEAR

500 WAYS TO DO IT WRONG AND ONLY ONE WAY TO DO IT RIGHT!

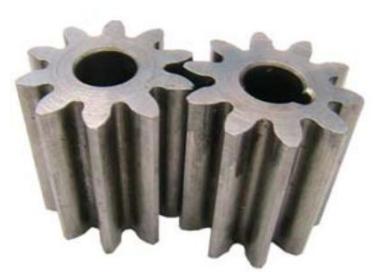
REPLACEMENT GEAR

I always put in a new oil pump when I rebuild an engine. The whole pump was available, not a kit like now. The new oil pump kits don't look like the old. The new gears are straight cut while the old ones are helical cut.

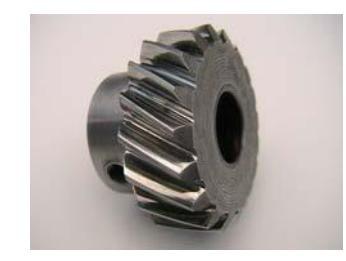
SMALL DRIVE GEAR FOR DISTRIBUTOR AND OIL PUMP

At my next meeting with the Logic engineers I was much more humble. My ears were open and my mouth was shut. I learned there was going to be only one way to make this project work. The oil pump gears and housings must have the original tight tolerance, be helical cut, and must be made of a good grade of steel so as not to expand under normal operating temperatures of the engine. There could be no friction. Next to the valve train the oil pump has the most pressure on its surface. A bad oil pump gear will cause a bronze gear to fail in a short time. I'd need a bronze gear of the similar hardness as the original and a new small polished and hardened gear that would drive the oil pump and distributor. All of the small steel gears I have seen have a pattern cut in them. This was a highly polished and hardened gear when new. This is so it will not cut the bronze gear.

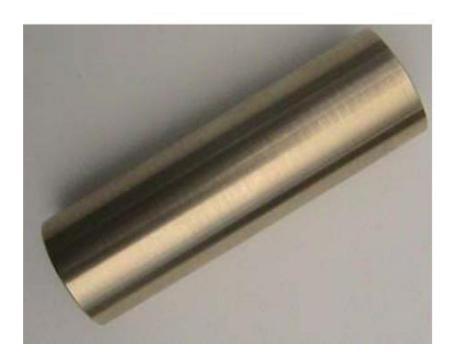
REPLACEMENT BUSHINGS

The distributor tower needed new bushings. The bushings I checked had wear .005 to 0.025 of an inch out of round. The pressure is all one way. There are many ways to put extra pressure on the bronze gear.

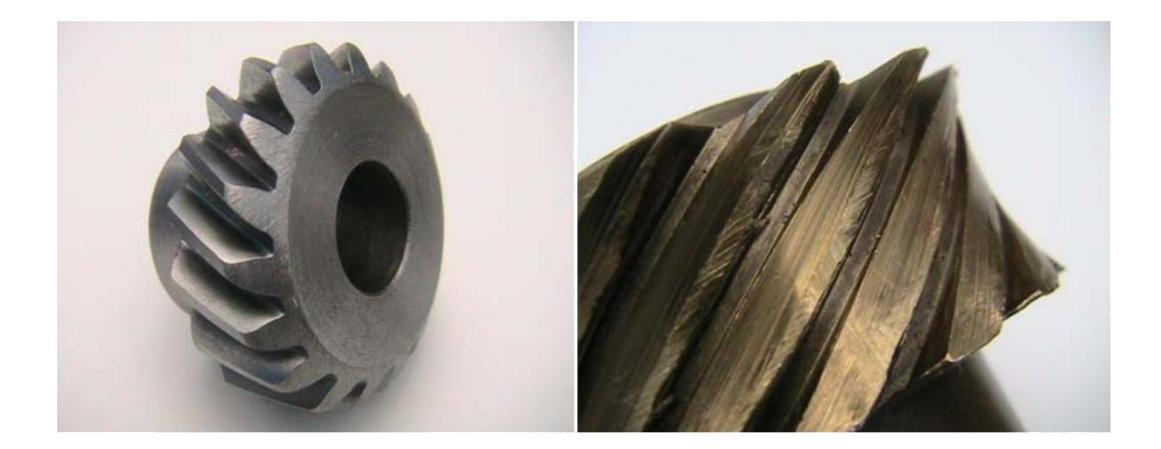
Problem: Worn Steel Gear: The steel drive gear was originally case hardened and polished surface. Technology of that era probably gave you a .003 to .005 thousands of hard steel. Every steel gear that I have inspected has worn thru the hardening. Viewing through a magnifying glass the teeth are very rough
Effect: Lack of a smooth surface soft steel will cause the bronze idler gear to wear at an accelerated rate.
