THE 1937-1948 CADILLAC AND LASALLE SACRIFICIAL BRONZE GEAR

500 WAYS TO DO IT WRONG AND ONLY ONE WAY TO DO IT RIGHT!

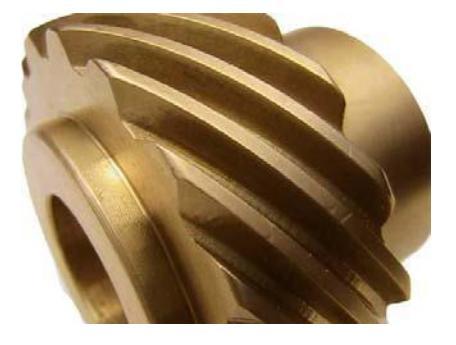
tips from members. The bronze gear is the idler gear that

connects the oil pump and distributor to the cam shaft in 1937 – 1948 Cadillacs and LaSalles

and, as the name suggests, it is made of bronze.

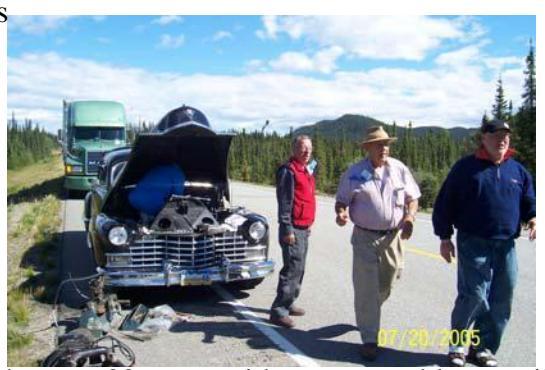
The straw that broke the camel's back, so to speak, was the failure of the bronze gear in my 1946 Cadillac after only 8,700 miles of use. My wife Zona, Jan Gerecke, and I were on the 2005 CCCA 'North To Alaska' driving tour and when the gear failed we were 40 miles from the nearest phone. Jan was driving when the engine suddenly backfired and then stopped running. We pulled over to the side of the road. Fortunately the caravan had a 'trouble truck' following so we did not

feel stranded. When the truck arrived one and half hours later Jan and I had taken apart the engine and had all the pieces neatly laid out on the road shoulder. I had to work hard to temper my anger as to why I could not rebuild a 346 cubic inch Cadillac engine that

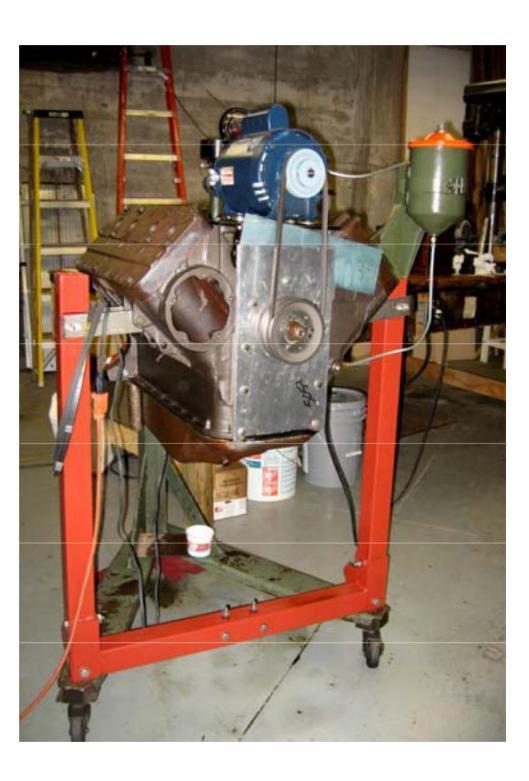
On February 16 I started the testing. I ran the engine at a speed equivalent to 70 mph with 40 lbs of oil pressure which is ten pounds more than Cadillac recommended. After the first week the engine had run the equivalent of 11,700 miles. I took everything apart and had the gears checked for wear. The bronze gear showed about 0.010 inch wear - not too good, not too bad. After the second week the equivalent travel was 23,200 miles and the gear showed 0.015 inch wear. At the end of the third week and 34,700 equivalent miles it showed about 0.025 inch wear. I had concerns at this point.

After the fourth week and 46,200 miles the gear still showed 0.025 inch wear. I felt better! After the fifth and sixth week and 57,700 miles and 69,200 miles respectively, the wear remained stable at 0.025 inch. With close to 70,000 miles completed on this test, I decided it was time to change the test to more typical operating parameters. I set the test bed to run at an equivalent speed of 55 mph with the oil pressure at 30 lbs -- the high side recommended by Cadillac.

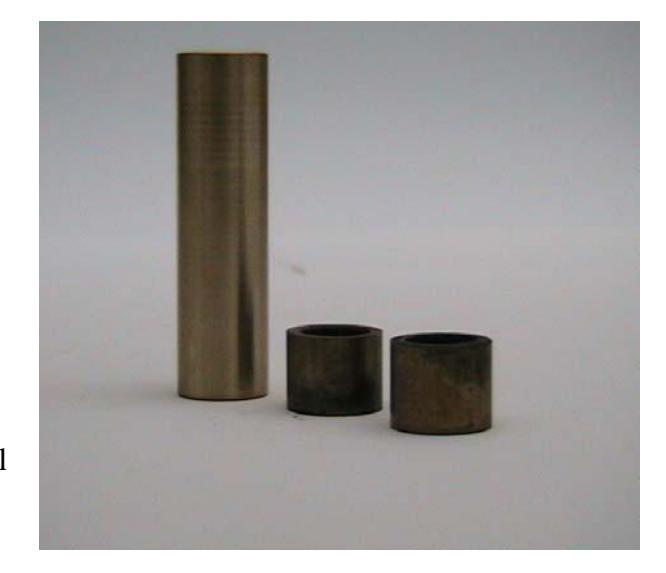
I called Jeff that morning to see if he had found anything unusual with the dimensions of the parts. He said several things could have closer tolerances, but found nothing that would cause the gear to wear out that fast. Jeff and I agreed that he would make a new set of gears to be tested. There would be 0.001 inch tolerance on all pieces, a new and improved bushing was

designed for the distributor tower with a polished shaft, and improved oil flow for the tower and gears.
