THE 1937-1948 CADILLAC AND LASALLE SACRIFICIAL BRONZE GEAR

THERE ARE 500 WAYS TO DO IT WRONG AND ONLY ONE WAY TO DO IT RIGHT!

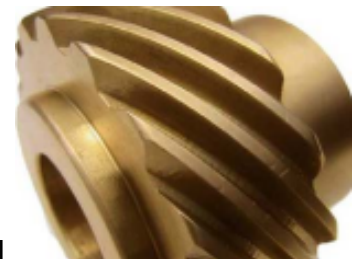
If your “bronze gear” is showing any amount of wear, it is telling you something. A few years ago I discovered that I could no longer rebuild a 346 cubic inch Cadillac or a 322 cubic inch LaSalle engine and keep it running for more than a few thousand miles without the bronze gear failing. Thanks to many club members I soon discovered I was not alone. This article includes many tips from members. The bronze gear is the idler gear that connects the oil pump and distributor to the cam shaft in 1937 – 1948 Cadillacs and LaSalles and, as the name suggests, it is made of bronze.

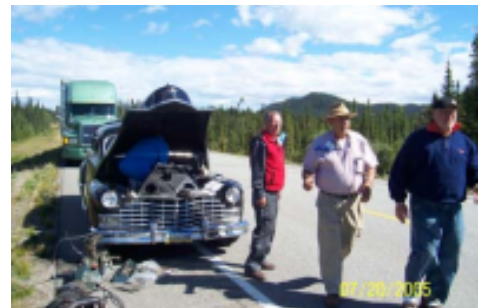
The straw that broke the camel’s back, so to speak, was the failure of the bronze gear in my 1946 Cadillac after only 8,700 miles of use. My wife Zona, Jan Gerecke, and I were on the 2005 CCCA ‘North To Alaska’ driving tour and when the gear failed we were 40 miles from the nearest phone.

Jan was driving when the engine suddenly backfired and then stopped running. We pulled over to the side of the road. Fortunately the caravan had a 'trouble truck' following so we did not feel stranded. When the truck arrived one and half hours later Jan and I had taken apart the engine and had all the pieces neatly laid out on the road shoulder. I had to work hard to temper my anger as to why I could not rebuild a 346 cubic inch Cadillac engine that would last. I have rebuilt more than twenty of them in the past 30 years with nary a problem until just a few years ago. Now I was sitting on the side of the road in "bear country" Alaska trying to figure out what had changed.

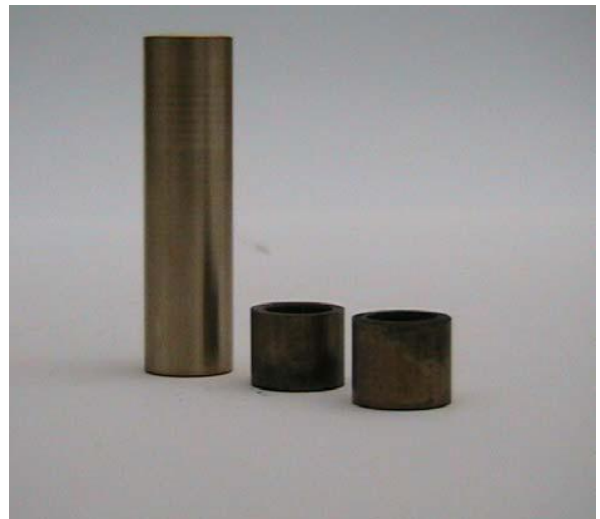
I called Jeff that morning to see if he had found anything unusual with the dimensions of the parts. He said several things could have closer tolerances, but found nothing that would cause the gear to wear out that fast. Jeff and I agreed that he would make a new set of gears to be tested. There would be 0.001 inch tolerance on all pieces, a new and improved bushing was designed for the distributor tower with a polished shaft, and improved oil flow for the tower and gears.
